MD 24 (Rocks Road) Slope Repair Project Priority Sections

Stream Evaluation & Slope Stabilization Techniques

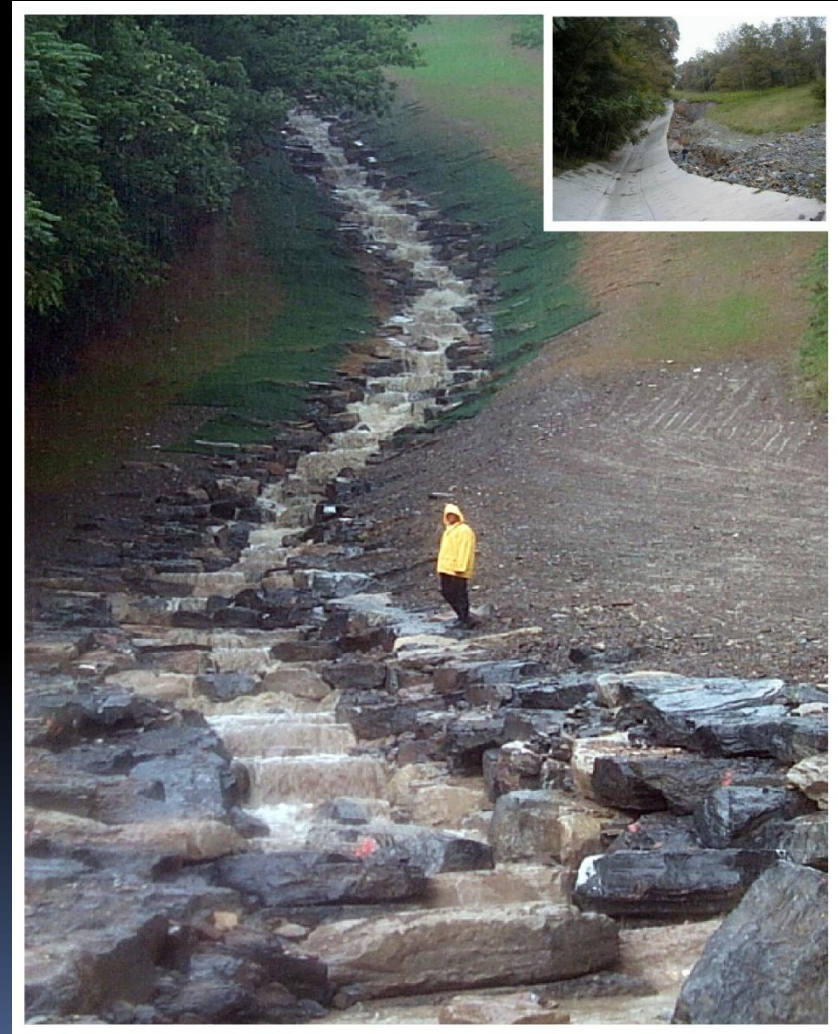
Example SHA Project –

Porter Run (Tributary to Braddock Run)

Western Maryland -Concrete Channel
